## Granaries

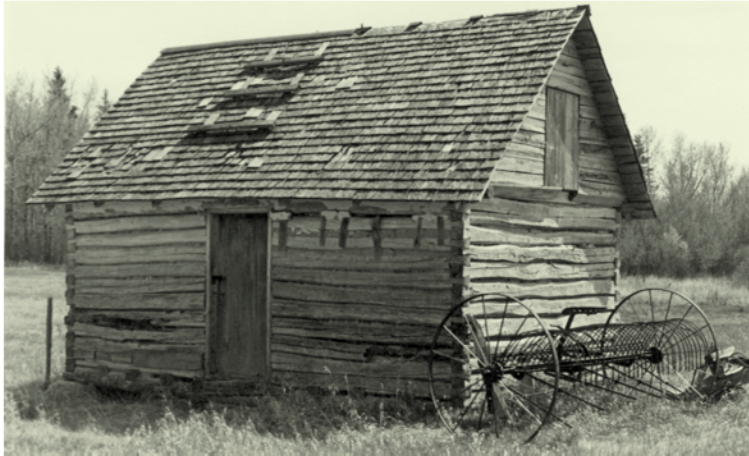
**Figure 33**  
Babiak granary, NE 1-18-3E, ca. 1925.

Although only small amounts of grain were grown during the early years, most Ukrainian farmyards in the planning district included at least one granary. Most granaries were simple, one-roomed log structures with wooden floors and gable roofs (Figure 33).

The walls were carefully chinked, and the exterior was whitewashed to give the building a traditional Ukrainian appearance. Granary walls were rarely given a mud plaster coating.

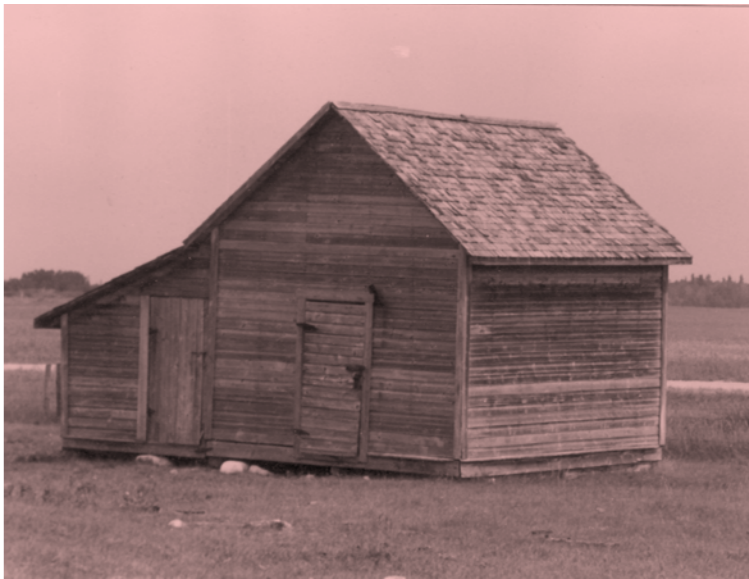
**Figure 34**  
Granary, SE 33-21-3E, ca. 1940.

In later years the interiors of many of the granaries were sheathed with tin to better seal the structure and to help prevent losses to rodents. Bulk grain was not normally handled until the appearance of the self-propelled combine during the late 1930s and early 1940s, at which time granaries of modern design and frame construction were built (Figure 34).

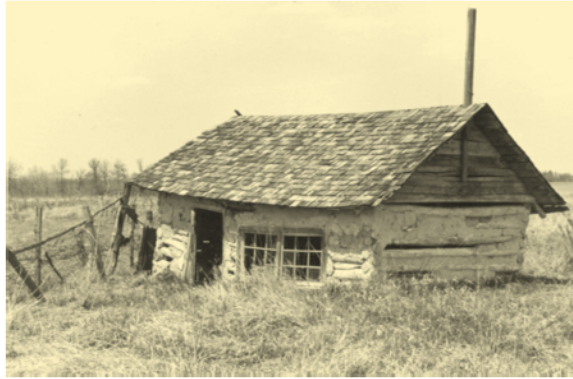
**Figure 35**  
Chicken coop, SW 8-18-4E.

The chicken coop was an integral part of the Ukrainian farmyard for many years. The raising of poultry was an important facet of pioneer life; they could be used for food, sale, or for feather tick bedding. When the settlers' first house was replaced with a new structure, the original was often converted into use as a chicken coop. The poultry structures were usually low-pitched gable roofed buildings with earth floors and mud plastered exterior walls and ceilings (Figure 35).

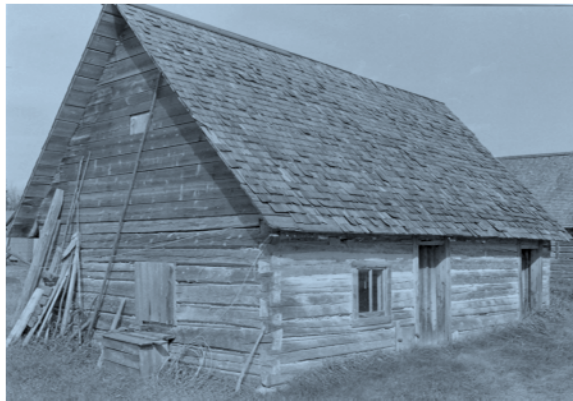
**Figure 36**  
Stelmach coop and hog barn, SW 27-24-3E, 1922.

Most had only one room, although a few of the remaining examples had a small feed storage room inside the main doorway. A characteristic of these structures, which clearly distinguished them from other small farmyard buildings, was the large window openings along the south wall. This feature provided a bright interior that was necessary for good egg production. A well-constructed chicken coop at SW 27-24-3E is an example that was combined with a hog shed (Figure 36).

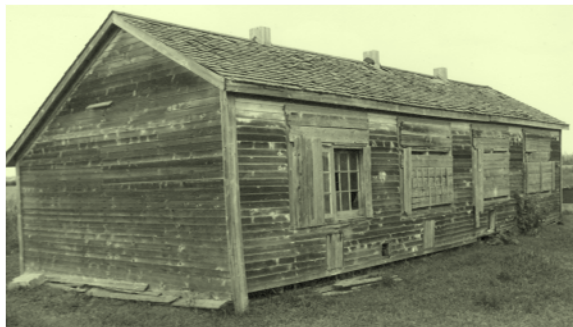
**Figure 37**  
Chicken coop, NW 10-22-3E.

After the 1920s, individual structures were constructed especially for this function. Frame lumber structures began to appear during the 1930s on the farms where large flocks of poultry were raised (Figure 37).

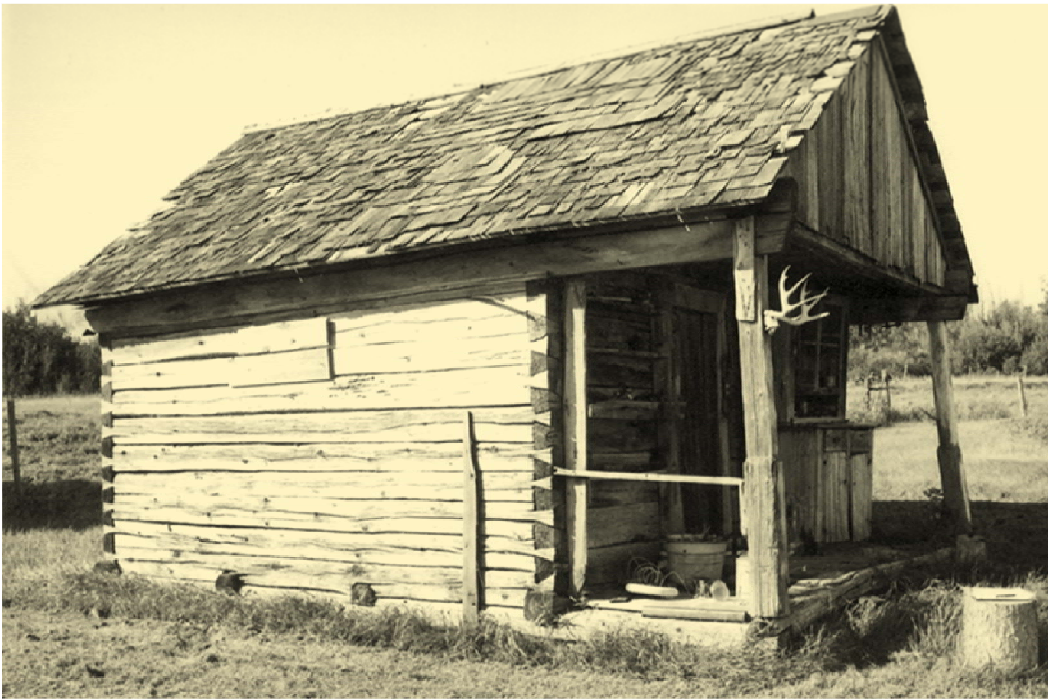
**Figure 38**  
Lemecha komora, SW 23-21-3E, ca.  
1920.

Another standard component of early Ukrainians farmyards was the "komora" or tool shed, which was used to store harnesses, hand tools, small equipment and other items. Like the granaries and chicken coops, the tool sheds were small, single-storeyed, one-roomed log structures usually with wooden floors and in some cases, prominent gable front projections (Figure 38).

This projection, accessed from the interior, not only provided additional storage space but sheltered an exterior work area as well. On the Lemecha komora, posts support the overhang, which has a raised wooden platform below. Its expert construction features a variety of carefully cut and fitted connections (Figure 39). One example, at NE 16-21-3E, had a shed-roofed front projection that is now enclosed (Figure 40).

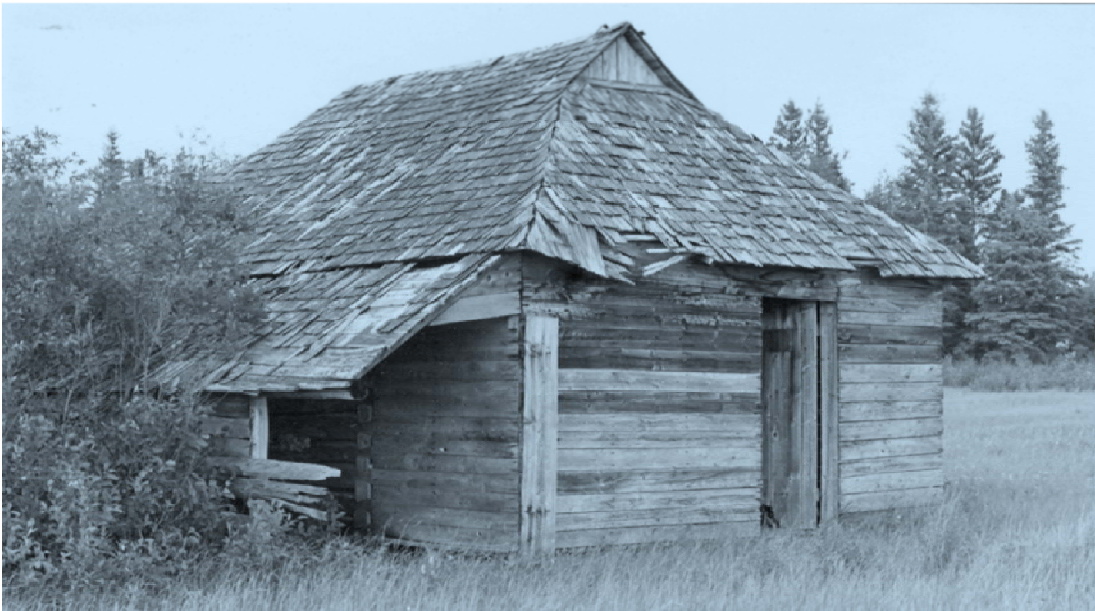
**Figure 40**  
Moga komora, NE 16-21-3E, ca. 1920.

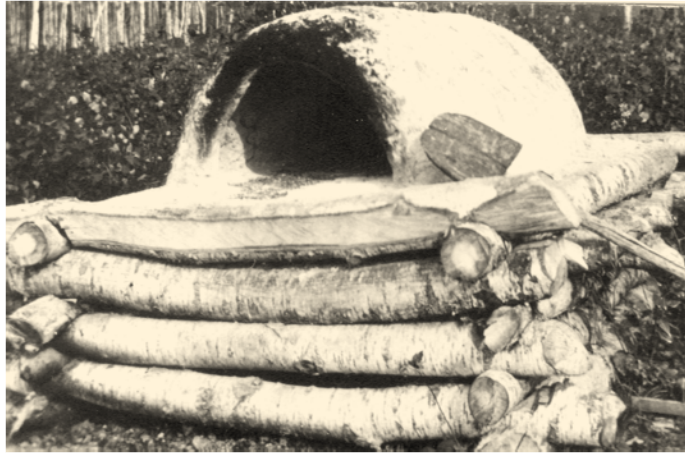
**Figure 41**  
An early bake oven.  
(Provincial Archives Manitoba)

With the food preparation done in the kuchny during the warm summer months the house was left comfortably cool and relatively free from insects. These structures often doubled as a spare bedroom. Nearby the kuchny stood the traditional outdoor clay bake oven which was used for baking bread and other pastry products (Figure 41).

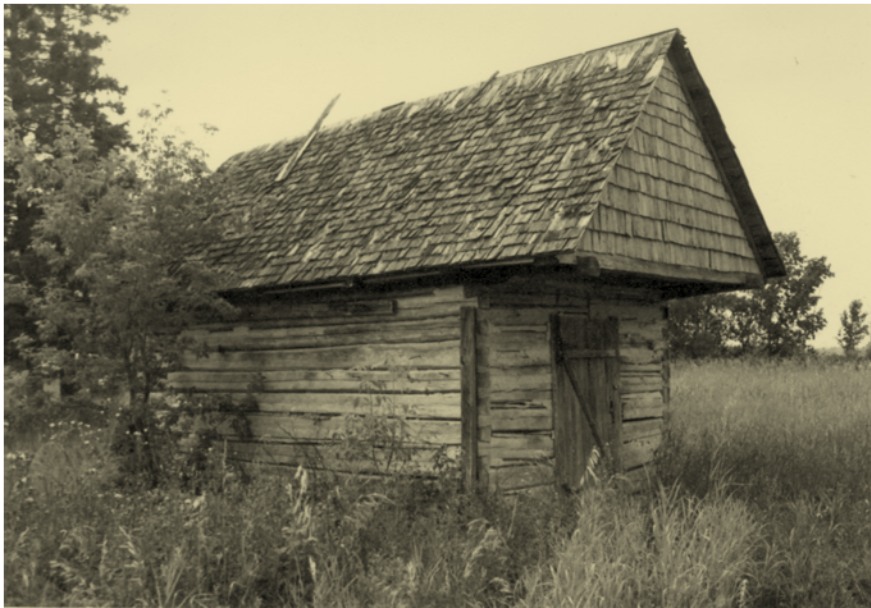
**Figure 42**  
Summer kitchen, SE 30-24-3E.

Only four summer kitchens were identified in the planning district. One featured the gable front projection more commonly found on the tool sheds (Figure 42), while the others had simple gable roofs.
